Service Campaign Bulletin

Campaign No. 2005060018
July 2005

SUBJECT: **MODEL 171, MODEL YEAR 2005
CHECK RACK AND PINION STEERING BOOTS AND REPLACE RACK AND PINION
IF NECESSARY**

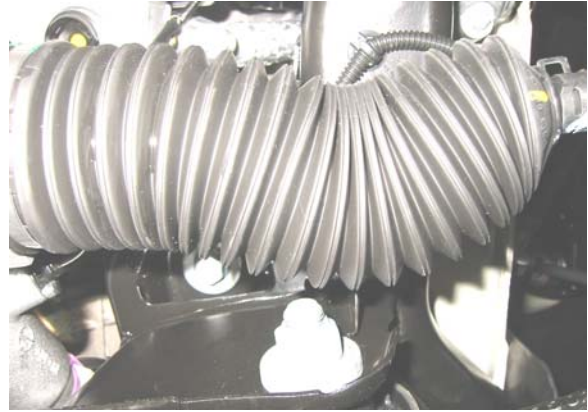
Figure 1

1. Place vehicle on lift (refer to WIS: AR00.60-P-1000V).
2. Remove center (lower) engine compartment panel.
3. Visually check both rack-and-pinion steering boots for damage:
 - If both boots are normal/undamaged (Figure 1), reinstall center engine compartment panel. No further work is necessary; campaign is complete.

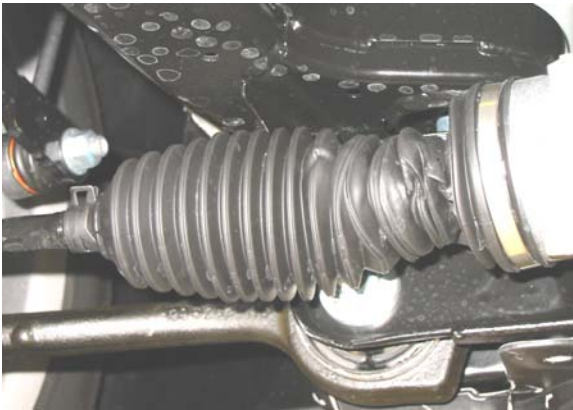
Figure 2

This Service Campaign has been initiated because DCAG has determined that on the affected vehicles (see VIN range below) the rubber boot on the rack and pinion may have been deformed during assembly. Dealers are to check the boots and replace the rack and pinion if necessary.

- If one or both bellows is/are deformed as shown (Figures 2, 3), proceed to next step.
4. Replace rack-and-pinion steering assembly (refer to WIS: AR46.20-P-0600V).
