DTB

Date: January 13, 2005
Order No.: P-B-09.20/19
Supersedes:
Group: 09

**SUBJECT: Model 171.456
Engine Performance / Check Engine Light On**

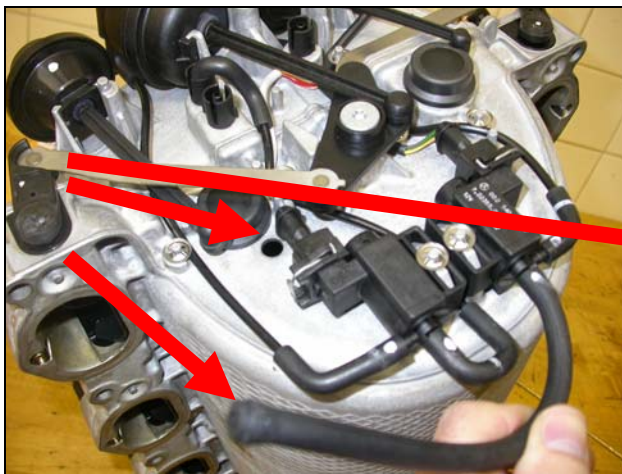
Figure 1

The condition may be caused by the vacuum hose for the vacuum supply for the air routing flaps and turbulence flaps at the intake module being cracked or torn off (Figure 1 and 2). Consequently, un-metered air is entering the engine causing the above condition.

If you receive customer reports in the above model vehicles of engine runs rough at idle, poor performance, hard starting and/or check engine light activated (possible but not limited to one or more of the following codes stored in the engine control unit 0745, 0749, 0632, 0633, 0636, 0637, 0640, 0641, 0644, 0645, 0649, 0653, 0656), exchange the intake manifold module to resolve.
