**DTB**

Date: February 2, 2005  
Order No.: P-B-27.35/52  
Supersedes:  
Group: 27

**SUBJECT: Model 171.456**  
**Model 171.454/473, Model Year 2006**  
**Model 209.375/475**  
**Model 209.356/456, Model Year 2006**  
**Model 211.070**  
**Model 211.056/087/256/287, Model Year 2006**  
**Model 215.375**  
**Model 219.375**  
**Model 220.170/175**  
**Model 230.475**  
**No Transfer of Power from Automatic Transmission 722.9**

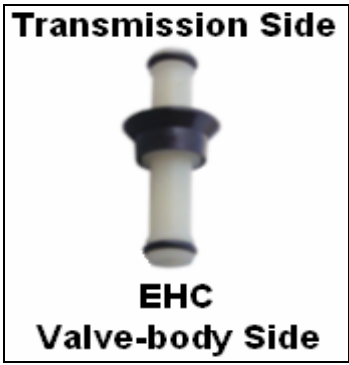
Figure 1 P-B-27.35/52

In the above model vehicles if after replacing the electro-hydraulic control unit on automatic transmission 722.9 (7G-Tronic) you experience the below conditions, this may be caused by an improper installation of the supply pipe for the multi-disc brake B3.

- No gear can be selected in transmission mode “S” and there is no power flow in the transmission
- In transmission mode “C” the vehicle can start off as usual.

To resolve, remove the electro-hydraulic control unit as described in WIS document AR27.19-P-0200w. Before reinstallation, install the supply pipe (Figure 1) per WIS document AR27.19-P-0200w, step 6. Replacement parts are only necessary if the original pipe was damaged during the original installation of the valvebody.
