Date: December 13, 2005
Order No.: P-B-27.60/64
Supersedes:
Group: 27

SUBJECT: Model 171.454/456/473, Model Year 2005 – 2006
Model 203.052/054/056, Model Year 2006
Model 209.356/456, Model Year 2006
Model 209.375/475, Model Year 2005 – 2006
Model 211.056/256, Model Year 2006
Model 211.070, Model Year 2004 – 2006
Model 220.170/175, Model Year 2004 – 2006
Model 219.375, Model Year 2006
Model 215.375, Model Year 2004 – 2006
Model 230.475, Model Year 2004 – 2006
Equipped with 7G-Tronic (722.9) Transmission
Learning in Selection Range Sensor Not Possible After EHS Replacement

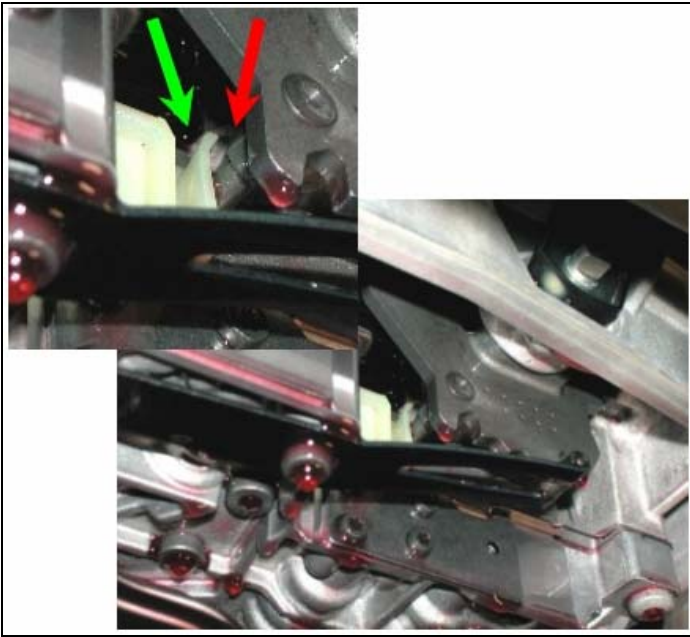
Figure 1

In the above model vehicles, after removing / installing the electrohydraulic control unit (EHS), learning in the selection range sensor is not possible if the retaining bolt of the detent plate was not inserted into the plastic bracket of the selector range valve (Figure 1). During initial startup with Star Diagnosis, the message "The prerequisites are not fulfilled or the peripherals are not operational" is displayed, although the shift rod has been correctly adjusted. To resolve, remove / reinstall EHS being sure to insert bolt into bracket on valve and proceed to teach the sensor using Star Diagnosis.
