**DTB**

Date: November 30, 2004  
Order No.: P-B-54.18/118  
Supersedes:  
Group: 54

**SUBJECT: Model 171.456, Up to VIN F029642 (Production Date 8/24/04)  
Check Engine Light On**

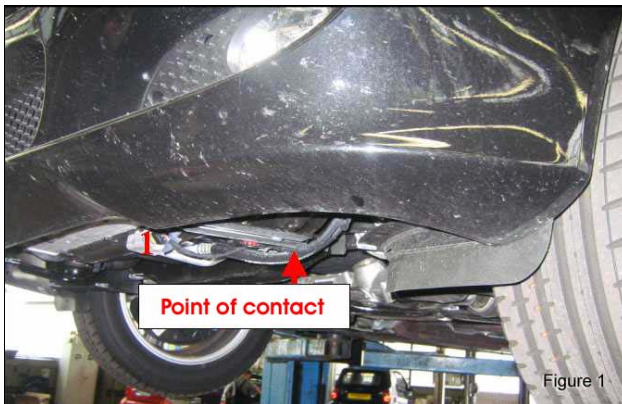
Figure 1 P-B-54.18/118

If you receive customer reports in the above model vehicle of the check engine light being activated (various fault codes stored in engine ECU) and fuse N10/1f54 has blown, this may be due to possible chafing of the engine wiring harness at the front left lower engine compartment panel bracket (Figure 1 and 2). If chafing marks are found, proceed as follows to resolve.

1. Disconnect battery ground. Refer to WIS document AR54.10-P-0003V.
2. Remove encapsulation panels. Refer to WIS document AR61.20-P-1105TX.
3. Detach connectors of refrigerant pressure sensor (Figure 1, 1) and suction fan (Figure 2, 2).
