DTB

Date: February 23, 2005
Order No.: P-B-68.10/34
Supersedes:
Group: 68

**SUBJECT: Model 171.456/473
Glove Compartment Lid Remains Locked**

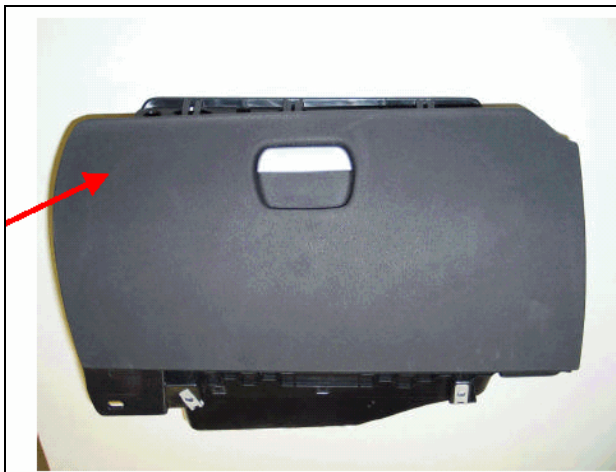
Figure 1

If you receive customer reports in the above model vehicle that the glove compartment lid remains locked when the car is unlocked, the central locking module may be sticking or the interior central locking relay pin may be either broken or bent. Perform the following steps to resolve.

1. Press the top left corner of the glove compartment lid (Figure 1, arrow) and then lock and unlock the central locking with the interior switch.
2. If the glove compartment still does not open, repeat the above procedure until the lid unlocks.
3. With the glove compartment lid open, grease the two locking pins and the groove (Figure 2, arrow) in the left locking pin.
4. Check the locking pins for smooth movement.
5. Inspect the pin on the interior central locking relay for damage.
