DTB

Date: November 10, 2005
Order No.: P-B-68.20/43a
Supersedes: P-B-68.20/43 dated November 3, 2005
Group: 68

SUBJECT: Model 171.454/456/473

Center Armrest/Storage Compartment Cover Cannot Be Opened

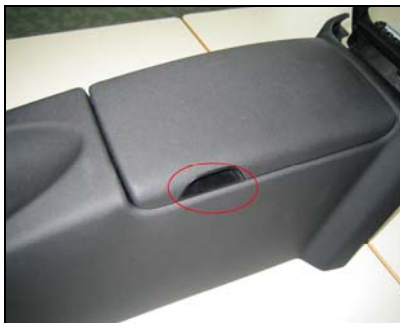
Figure 1 P-B-68.20/43

1. The side buttons (Figure 1, circle) are jammed and the hinge pin (Figure 2, circle) at the rear of the cover does not engage correctly.
2. Push down on the rear edge of the center armrest/storage compartment cover (Figure 3, arrows) so the hinge pin can engage correctly.
