DTB

Date: November 14, 2005
Order No.: P-B-72.10/51
Supersedes:
Group: 72

**SUBJECT: Model 171.454/456/473
Wind Noise and/or Water Leak Between Door Glass and Rear Quarter Window**

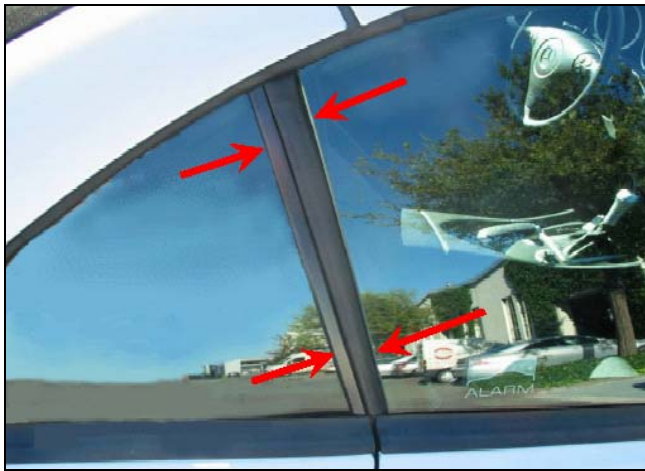
Figure 1 P-B-72.10/51

If you receive customer reports in the above model vehicles regarding wind noise and/or water leak from the area between the door glass and the rear quarter window, this may occur if the gap between these windows is not parallel or even (Figure 1, arrows) when the windows are fully closed. The non-parallel or uneven gap can occur if either or both windows are adjusted too far rearward. To resolve, perform the below adjustments.
