**DTB**

Date: February 17, 2005  
Order No.: P-B-82.85/437  
Supersedes:  
Group: 82

**SUBJECT: Model 171.456, Model Year 2005  
Model 171.454/473, Model Year 2006  
Model 211.026/065/070/076/082/083/265/282/283, Model Year 2004 and Later  
Model 211.056/087/256/287, Model Year 2006  
Model 219.375/376, Model Year 2006  
Erroneously Changing Background, Keyboard Functions in Vehicles Equipped with  
COMAND Head Unit**

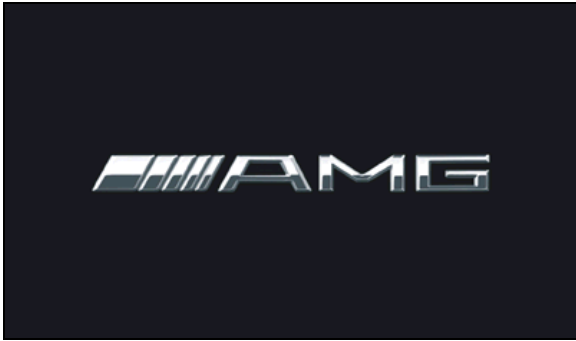
Figure 1 P-B-82.85/437  
Example of 211 head unit image with incorrect 171 or 211 AMG background.

1. Turn Ignition on and power ON the head unit
2. Press and hold the key combination (5+3+7) in this sequence for about 8 seconds to access the variants menu (Figure 3).
3. Scroll up or down and select the correct head unit variant for the subject vehicle, press OK to confirm.
4. Press the “**Keybrd.**” soft key for the list of possible keyboard types (Figure 4).

5. Scroll up or down and select the correct head unit Keyboard for the subject vehicle, press OK to confirm.
6. Upon correcting the variant and keyboard settings, turn ignition off and ensure MOST and CAN asleep.
7. Turn ignition ON and check the functionality of all keys on the head unit using different applications.

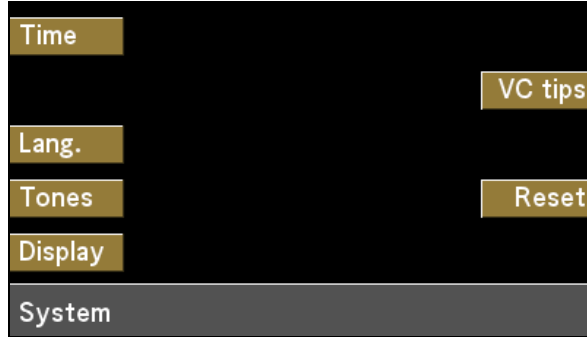
Figure 2 P-B-82.85/437  
Example of 240 system menu incorrectly selected on a 211 head unit
