DTB

Date: September 14, 2004
Order No.: P-B-91.60/78
Supersedes:
Group: 91

**SUBJECT: Model 171.456, VIN Range 000001 up to 018832
Model Year 2005
SRS Light Illuminated**

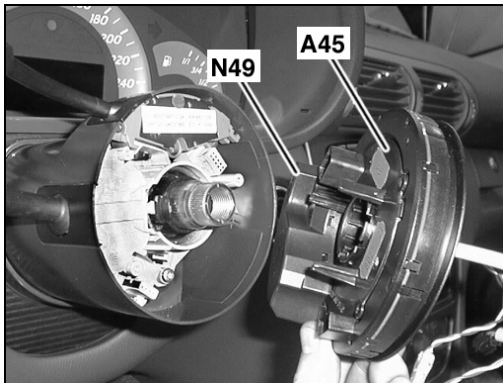
Figure 1

If you receive customer reports on the above model vehicles of SRS light illuminating and DTC 9103 [the resistance value in the ignition circuit containing component R12/13 is too high] and or 9123 [the resistance value in the ignition circuit containing component R12/14 is too high], the contact spiral (A45) may need to be replaced.

1. Remove and replace the contact spiral (A45) as per WIS instruction AR46.10-P-0200V.
2. Using STAR Diagnosis erase the above stored diagnostic fault codes
3. With engine running, turn steering wheel from lock to lock.
4. Verify that the SRS light does not illuminate.
