Date: December 9, 2004
Order No.: P-B-49.10/09
Supersedes:
Group: 49

**SUBJECT: Model 171.456, up to chassis F042765
Routing of O2 Sensor Harness**

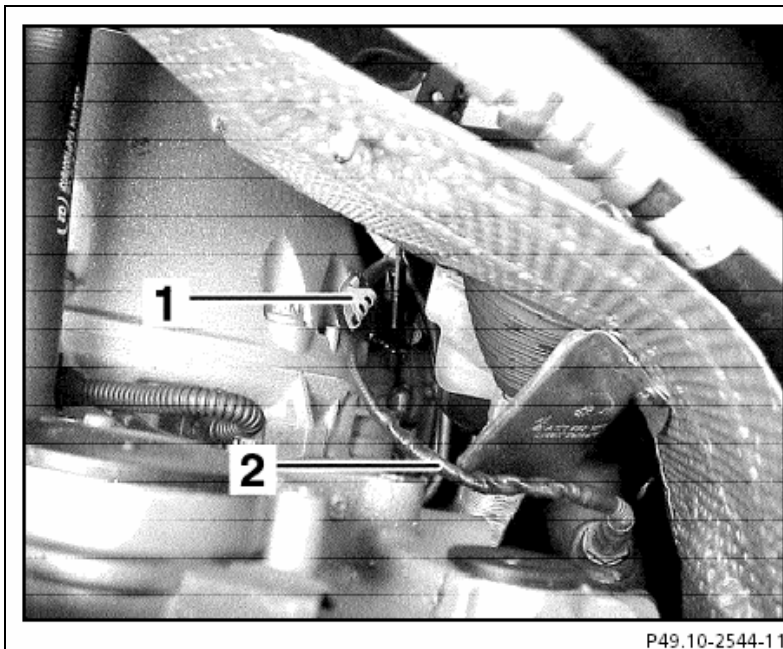
Figure 1

It is NOT required to have the O2 sensor harness (see picture item 2) on the left and right side secured in the retaining clip (Figure 1, 1). As of chassis # F042765 the retaining clips (Figure 1, 1) on the left and right side will no longer be installed.
